**Island Farm  
Site Wide  
Masterplanning.**

**Summary of Site  
Investigation Findings.**

24<sup>th</sup> February 2020

Job number 2019\_039

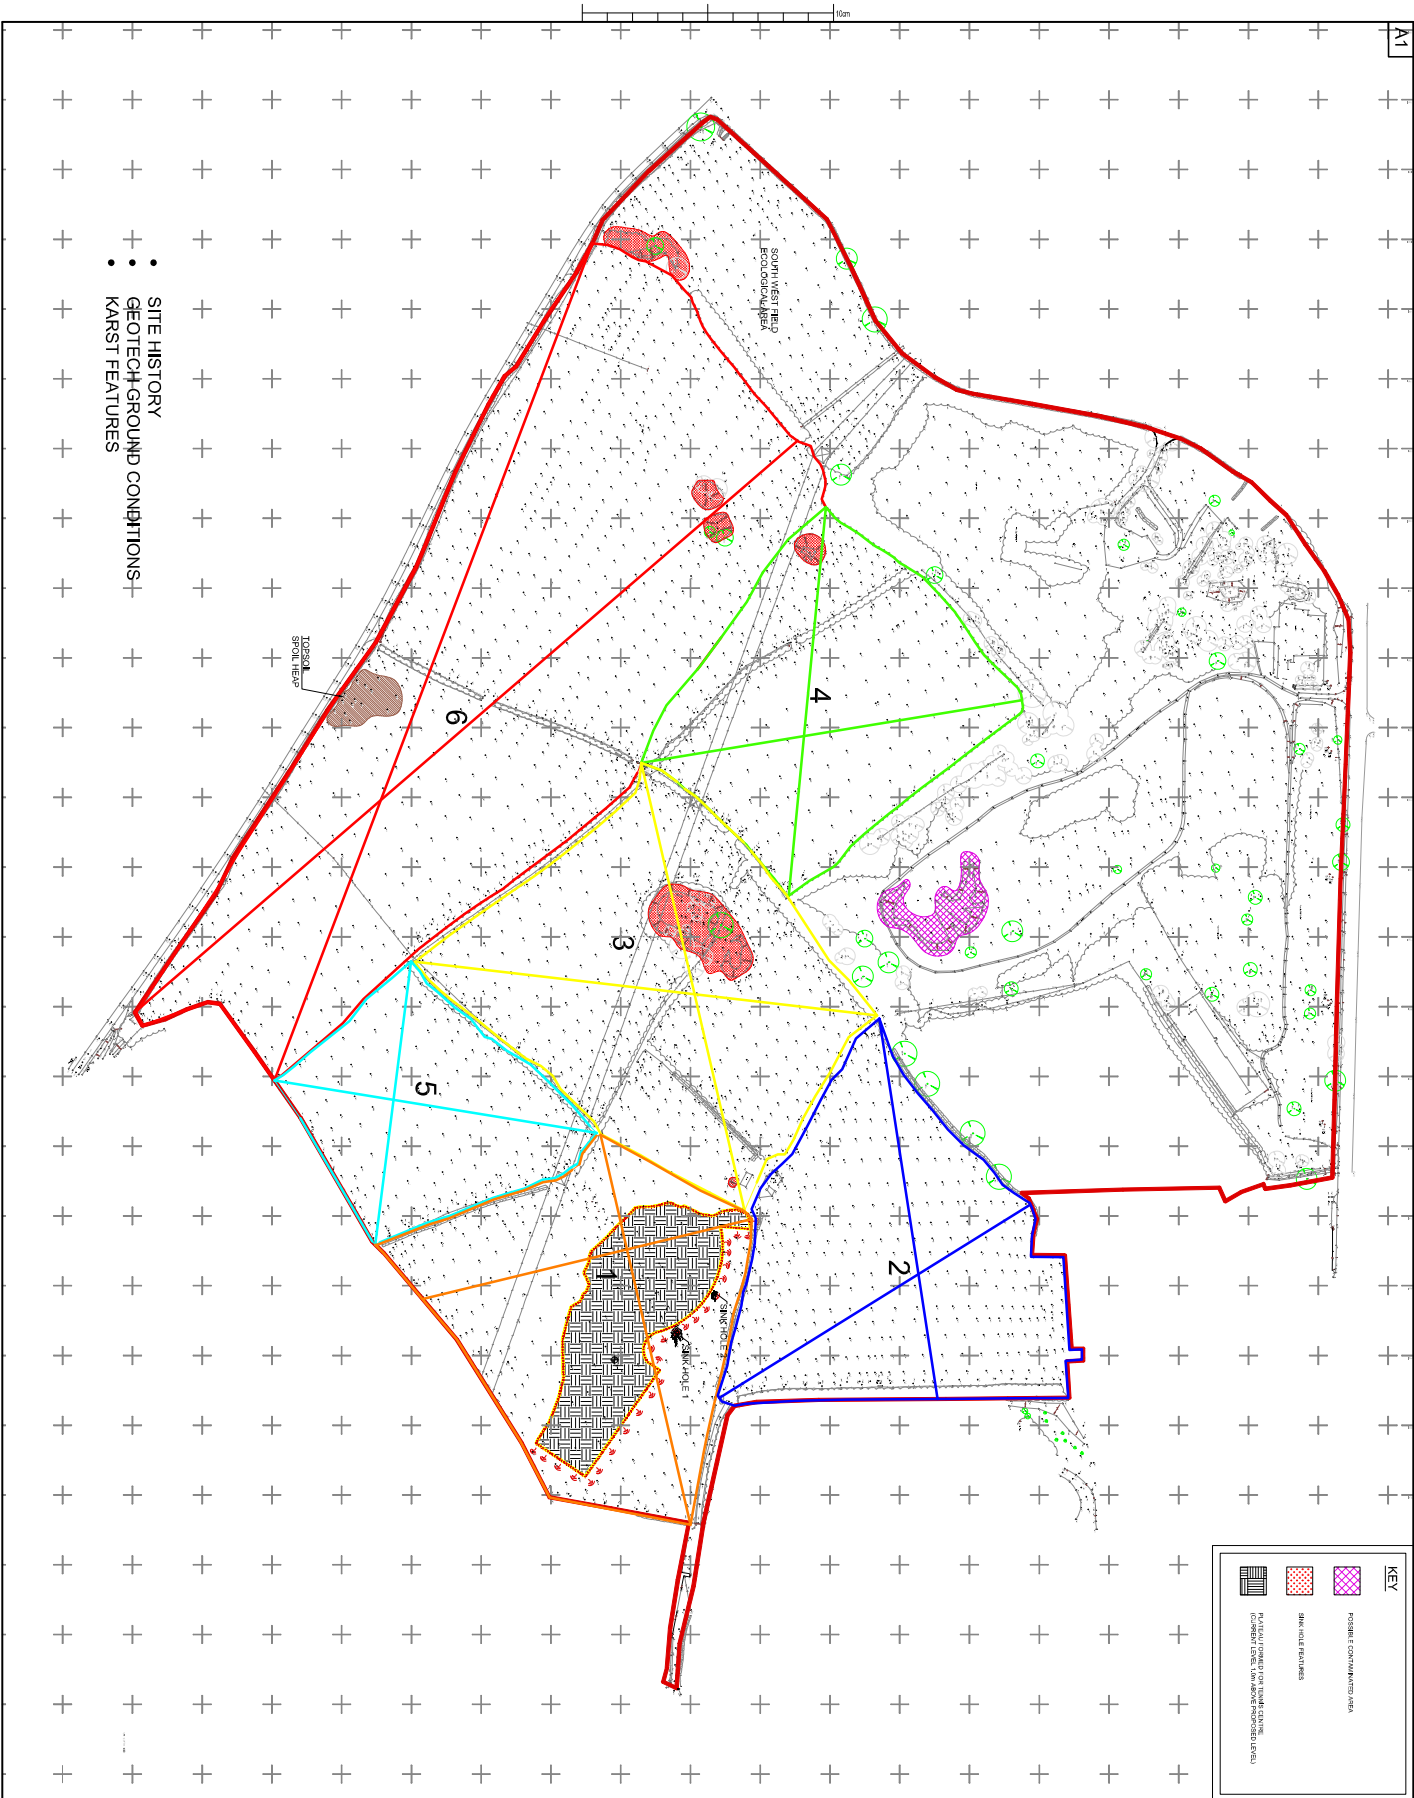
SITE LAYOUT

The known Karst features within the site are included on the site plan accompanying this summary.

Two Sinkholes have appeared within Zone 1, one which was mitigated/capped and backfilled and surveyed, the other which has been left open and is fenced off.

Solution features and suspected solution features are positioned within this area.

An area of fill believed to be arising from huts demolished on the site is located to the north east of Area 4 could well be contaminated. This area of spoil is highlighted on the attached site plan.
