Proposed Residential Development – Site A, Porthcawl

Geo-Environmental & Geotechnical Assessment

Report Reference: ESP.7044d.3123_A.Rev1

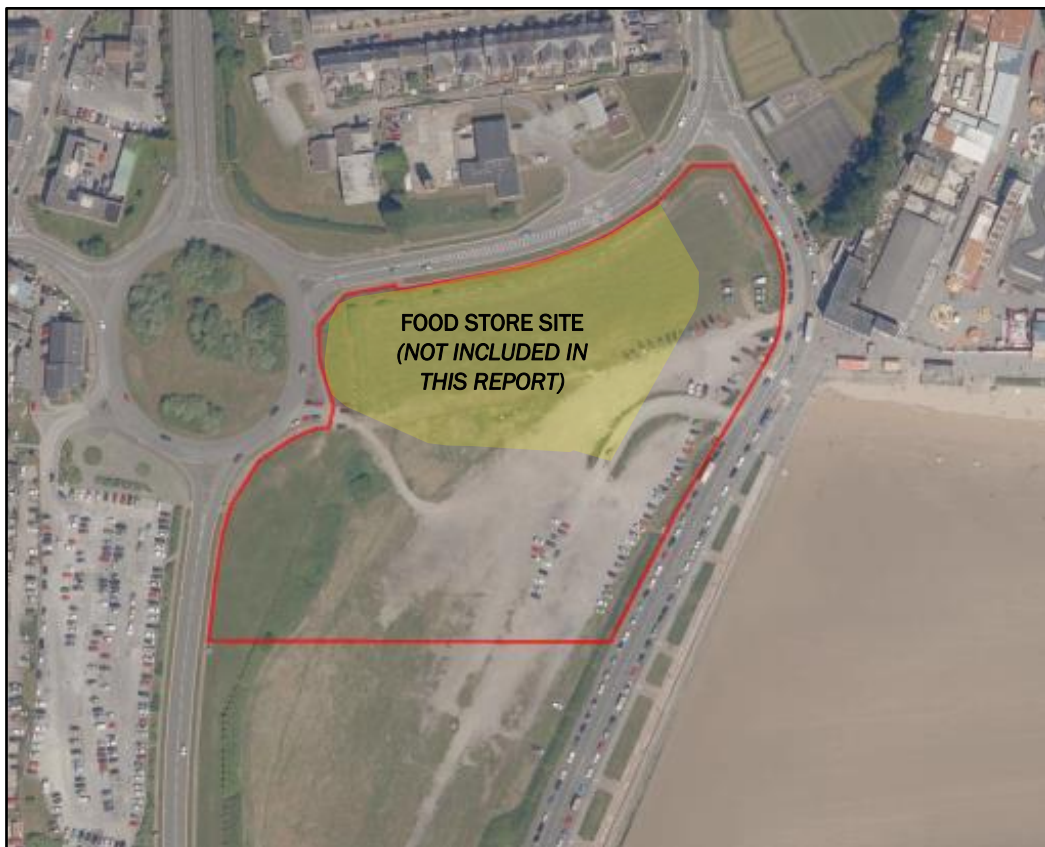
Insert 4 – Site A Aerial Image (from EnviroInsight report, Appendix C2)

As identified in Insert 4, the site is largely occupied by open rough grass areas, with compacted gravel surfacing in the east and centre. The gravelled areas are used as a public car park during the summer months, with access to the site via barriered access in the north east, with a short access road trending west and south west. The Food Store site is located adjacent to Site A in the north west, as indicated on Insert 3.

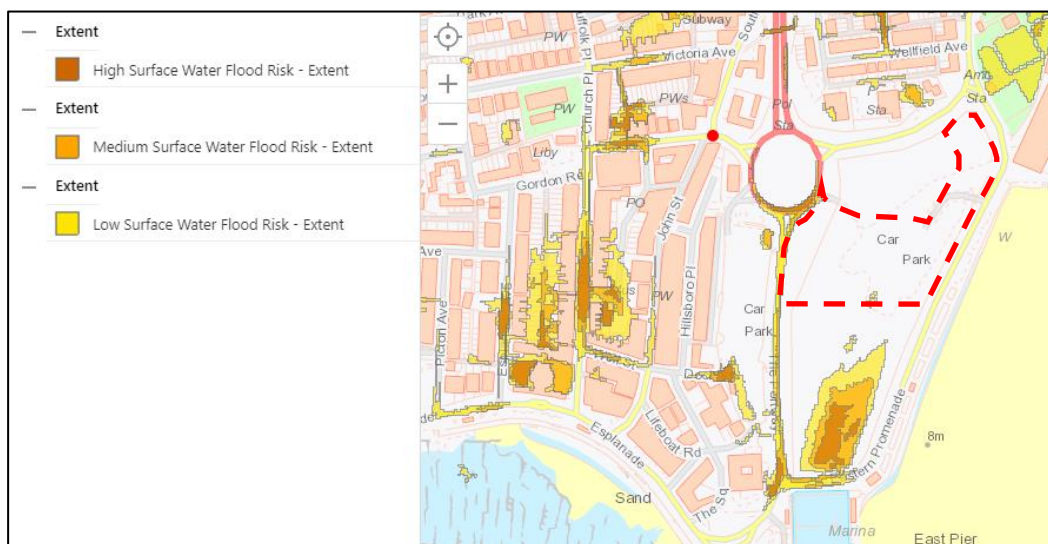
Insert 5 - Surface Water Flood Risk Map (NRW, 2019)

Very small, isolated areas of surface water flood risk are indicated on-site (see Insert 5), however a low to high risk is indicated on the roundabout/The Portway road adjacent to the west boundary.
